PRE-RENOVATION SURVEY
FOR
ASBESTOS-CONTAINING MATERIALS,
LEAD-BASED PAINT,
POLYCHLORINATED BIPHENYLS IN CAULK/SEALANTS
AND
HAZARDOUS MATERIALS
AT THE
BATAVIA POLICE STATION
LOCATED AT
10 WEST MAIN STREET
BATAVIA, NEW YORK
MAY 2014

PRE-RENOVATION SURVEY
FOR
ASBESTOS-CONTAINING MATERIALS,
LEAD-BASED PAINT,
POLYCHLORINATED BIPHENYLS IN CAULK/SEALANTS
AND
HAZARDOUS MATERIALS
AT THE
BATAVIA POLICE STATION

LOCATED AT
10 WEST MAIN STREET
BATAVIA, NEW YORK

MAY 2014

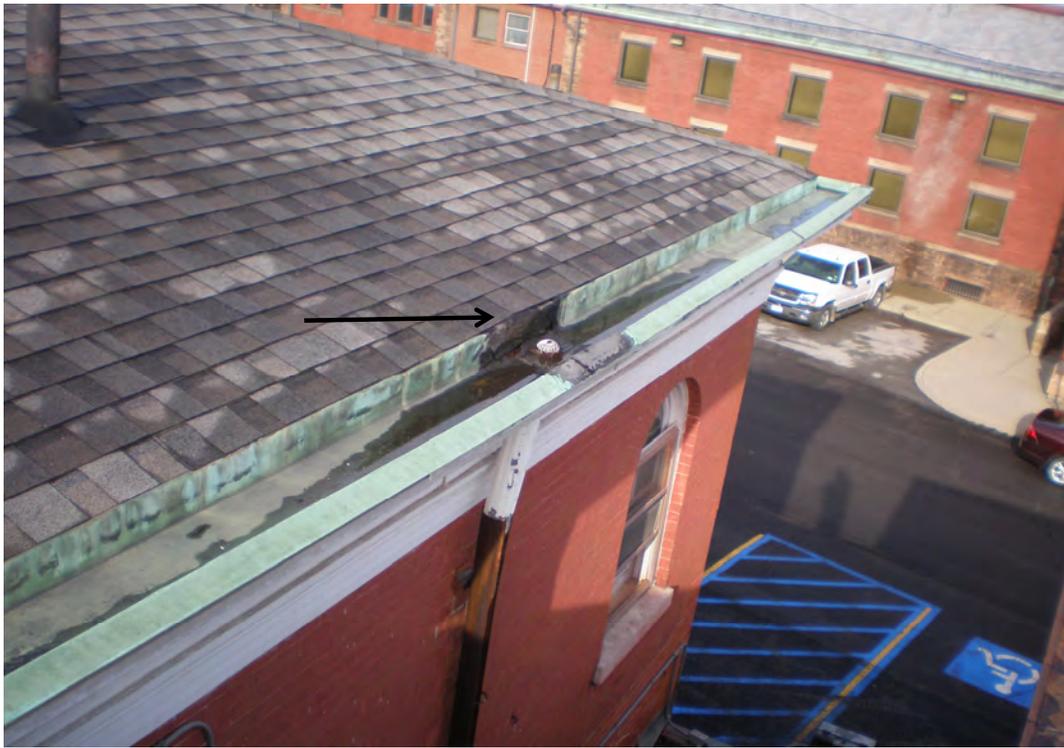
- **Black tar as discrete patches on the metal roof perimeter gutter.** The black tar was observed intermittently at seams and at the corners of the metal gutter along the roof perimeter for both the 1855 original building and the 1876 addition. The roof gutter was approximately 12 inches wide. The gutter length is approximately 220 linear feet at the edge of the 1855 original building and 119 linear feet at the edge of the 1876 addition. The asbestos-containing black tar was non-friable and appeared to be in good to fair condition.

Photo #1 - View of black roofing tar on the roof edge gutters, 1855 building. The black tar on the gutters is ACM (indicated with an arrow).
 Photo Date: 04/11/2014 ACM black roofing tar was observed on the gutters on the original 1855 building and 1876 and 1918 additions.

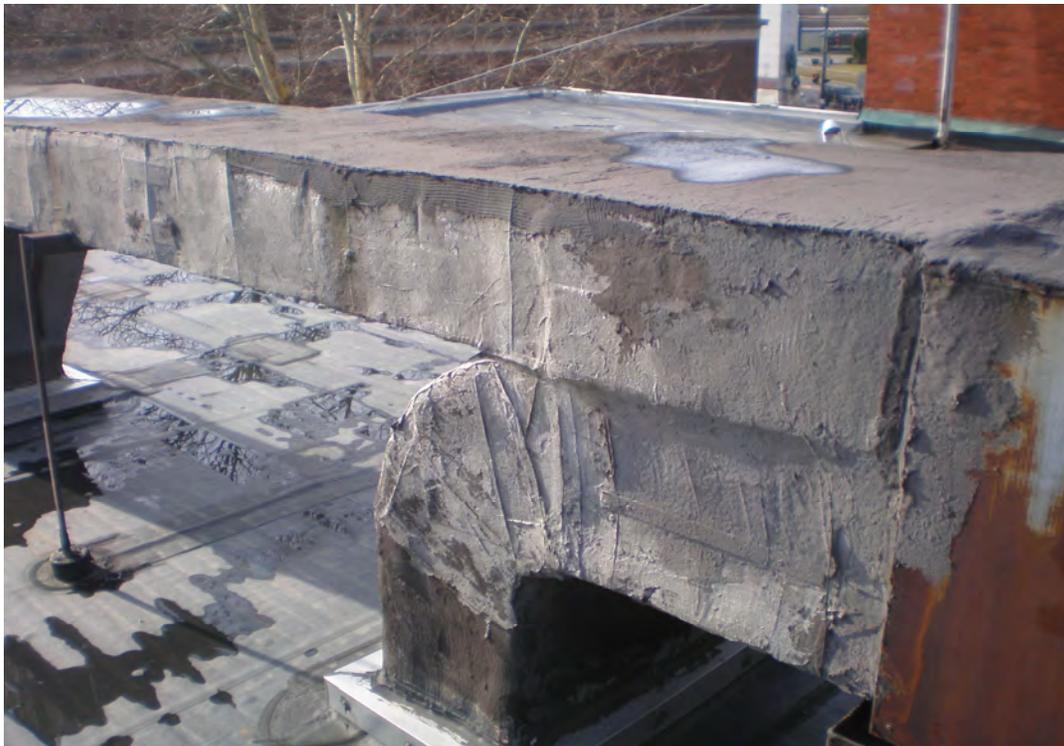
- **Black asphaltic wrap and black tar coating on the roof top duct work**. The roof top duct is elevated on short stilts and is approximately 28 feet long, varying width. The surface area of the roof top duct is approximately 130 square feet. The asbestos-containing black asphalt wrap and asbestos-containing black tar coating was non-friable and in good condition.

Photo #2 - ACM black tar on the HVAC unit on the flat roof of the 1963 addition.
 Photo Date: 04/11/2014

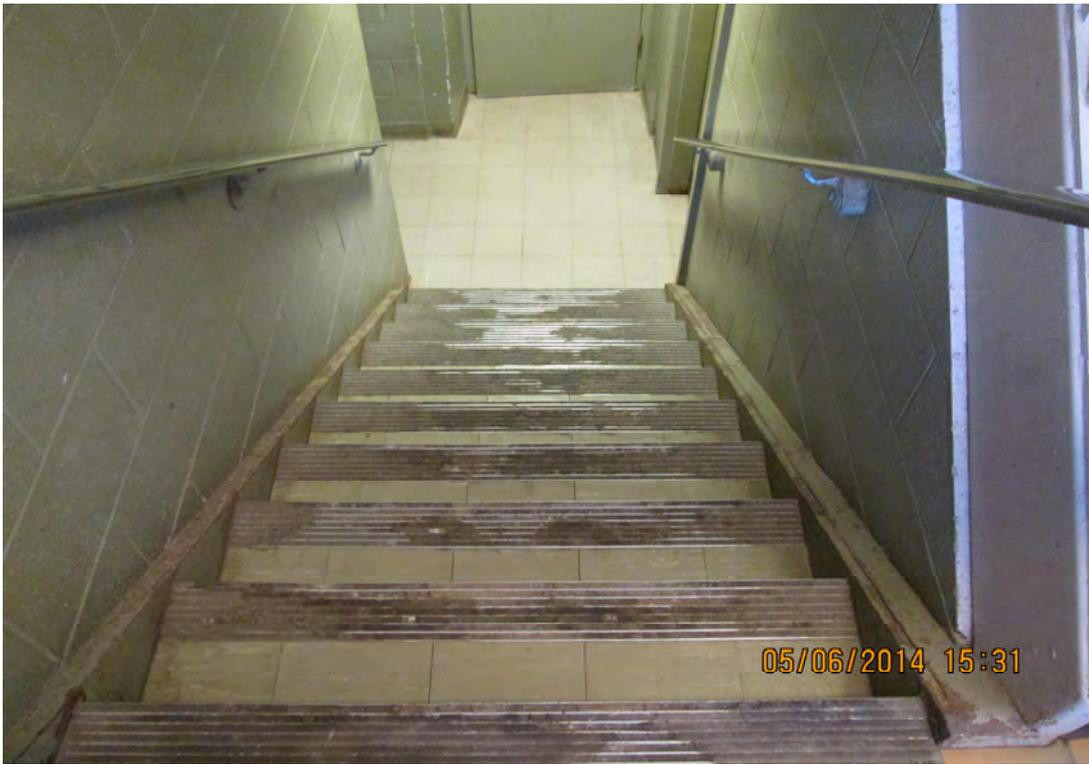
Photo #3 - View of ACM 9" x 9" floor tiles on the north stairwell, 1963 wing.
 Photo Date: 05/06/2014

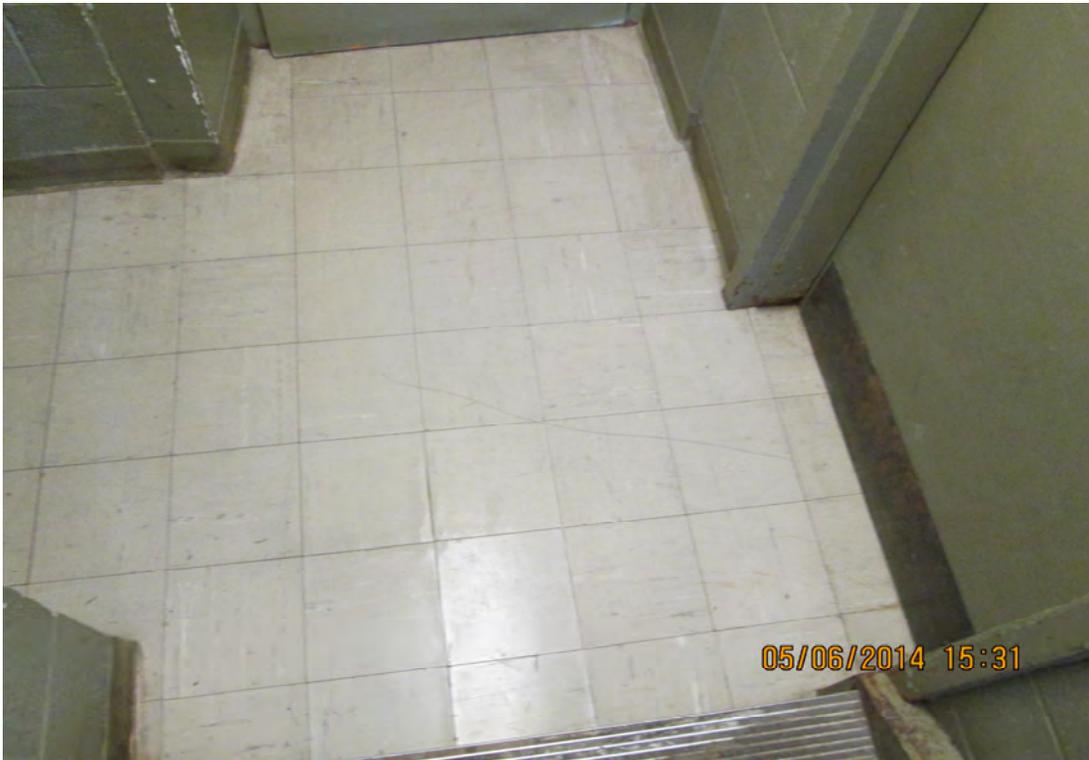
Photo #4 - View of ACM 9" x 9" floor tiles on the basement floor and adjacent break room, 1963 wing.
 Photo Date: 05/06/2014

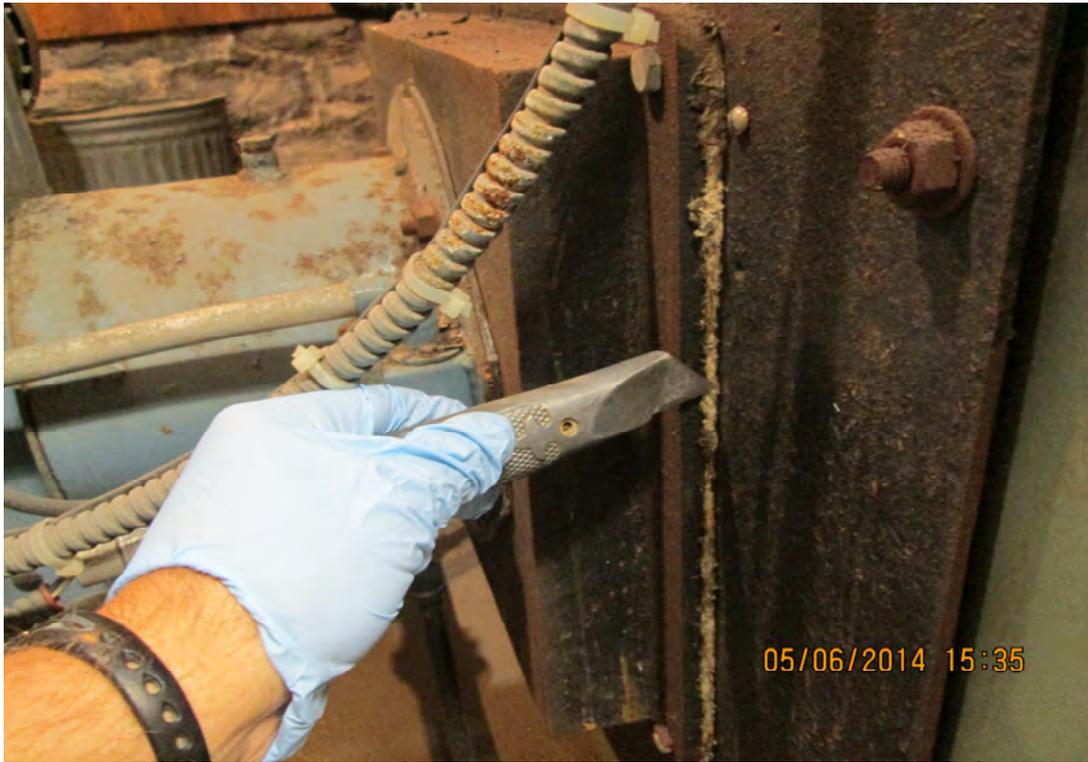
- **Door gasket, basement boiler** in the basement boiler room 1955 wing. ACM gasket material was observed on the flanges to the boiler in the basement room. The boiler was labeled with a "Danger Contains Asbestos Fibers" label. The boiler breaching is approximately two square feet and appeared to be friable and in good condition.

Photo #5 - View of the boiler in the basement of the 1855 wing. The gasket insulation on the boiler door is ACM.
 Photo Date: 05/06/2014

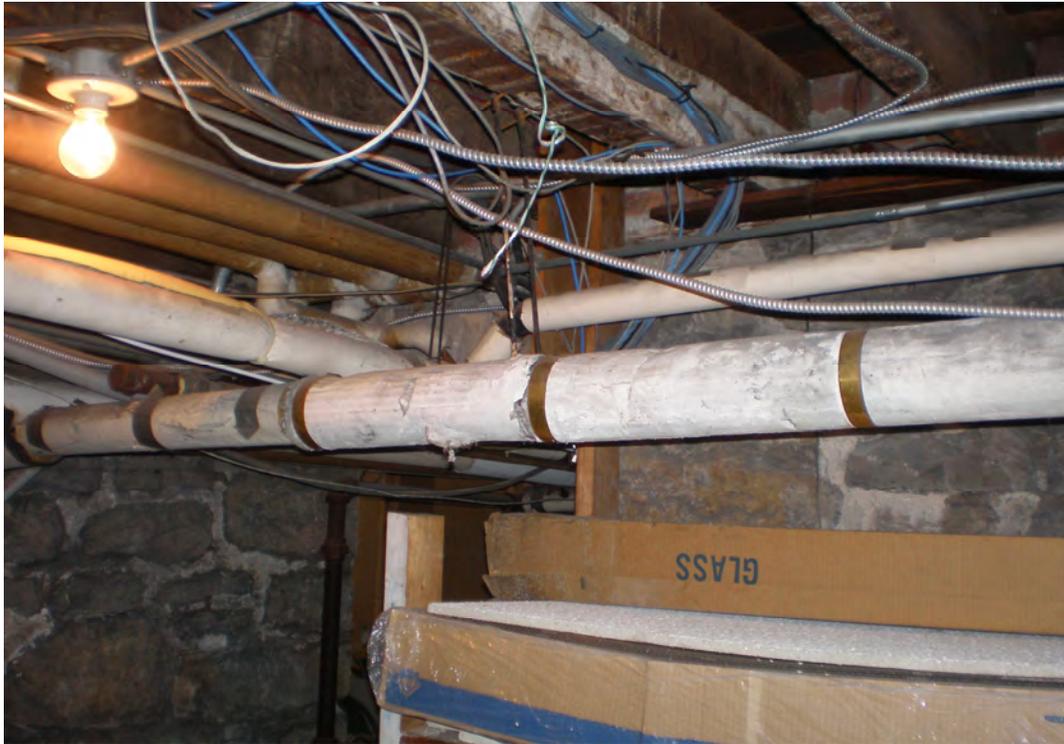
- **Aircell-type pipe insulation** observed on piping in the basement boiler room and above suspended ceiling tiles along the perimeter of the basement rooms and the basement beneath the 1876 addition. Approximately 300 linear feet of aircell-type insulation was observed in the basement. Insulated pipe diameters ranged from 2" to approximately 6". At several locations at the perimeter of the basement the aircell pipe insulation extended vertically into pipe chases to the 1st floor. This report assumes that ACM insulation is present on inaccessible piping extending through the floors through the first and second floors and may be present in wall chases. The accessible aircell pipe insulation was friable and varied in condition from good to poor. The aircell pipe insulation that was in poor condition was observed in the basement boiler room.

Photo #6 - Aircell-type insulation observed on piping in the 1855 building basement. This type of pipe insulation was confirmed as ACM.
 Photo Date: 04/11/2014

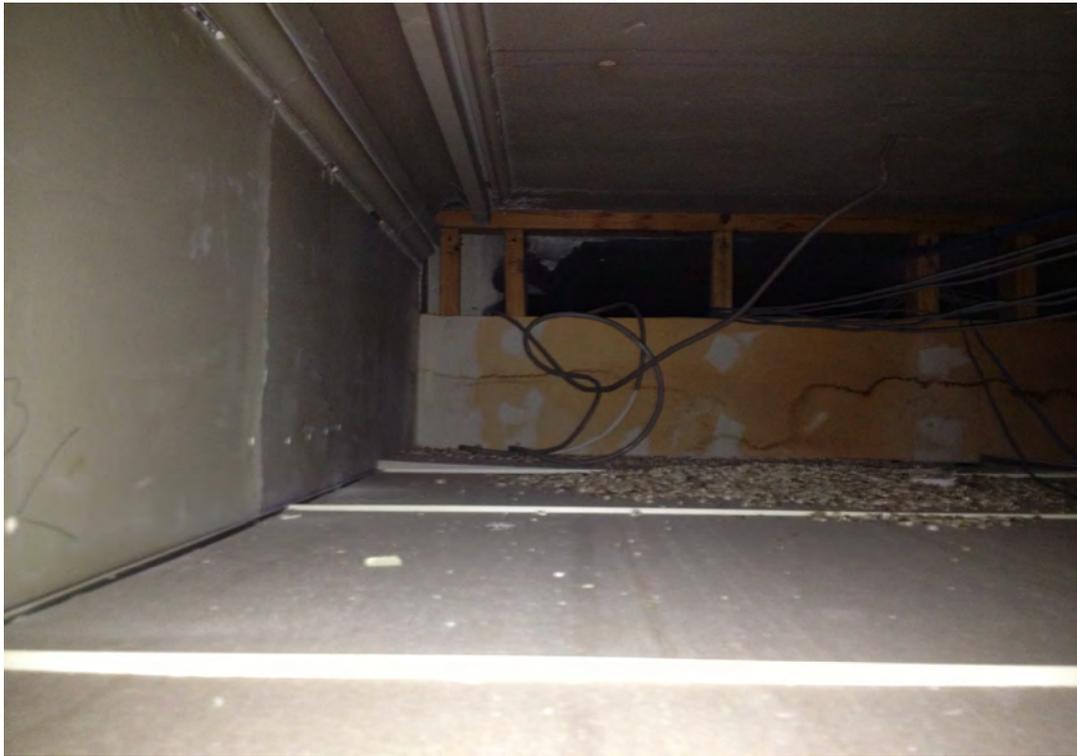
- **Loose vermiculite insulation** on top of 2' x 4' suspended ceiling tiles, 2nd floor break room, at the northwest corner of the room. Laboratory analysis on samples of the loose insulation on the ceiling tiles confirmed that the material contains vermiculite. A pile of approximately three square feet and about one inch thick of loose vermiculite was observed. Per the New York State Department of Health (NYSDOH) guidance dated July 9, 2013 attic, fill, block fill or other loose bulk vermiculite material must be designated and treated as ACM. No approved analytical method currently exists to reliably confirm such vermiculite material as non-ACM. The vermiculite detected on suspended ceiling tiles in the 1855 building 2nd floor break room was a loose material, typical of insulation that would be found in floor joists. The vermiculite is assumed to be present in the attic floor joints beneath the floor. The attic foot print is approximately 2,530 square feet, which is assumed to contain loose attic fill vermiculite, approximately 1,000 cubic feet, assuming 4" foot depth of the attic floor joists.

Photo #7 - View of loose vermiculite-containing insulation on suspended ceiling tiles in the 2nd floor break room, 1855 building.
 Photo Date: 04/25/2014 This type of loose insulation is considered to be ACM and is assumed to be in the 1855 attic floor boards.

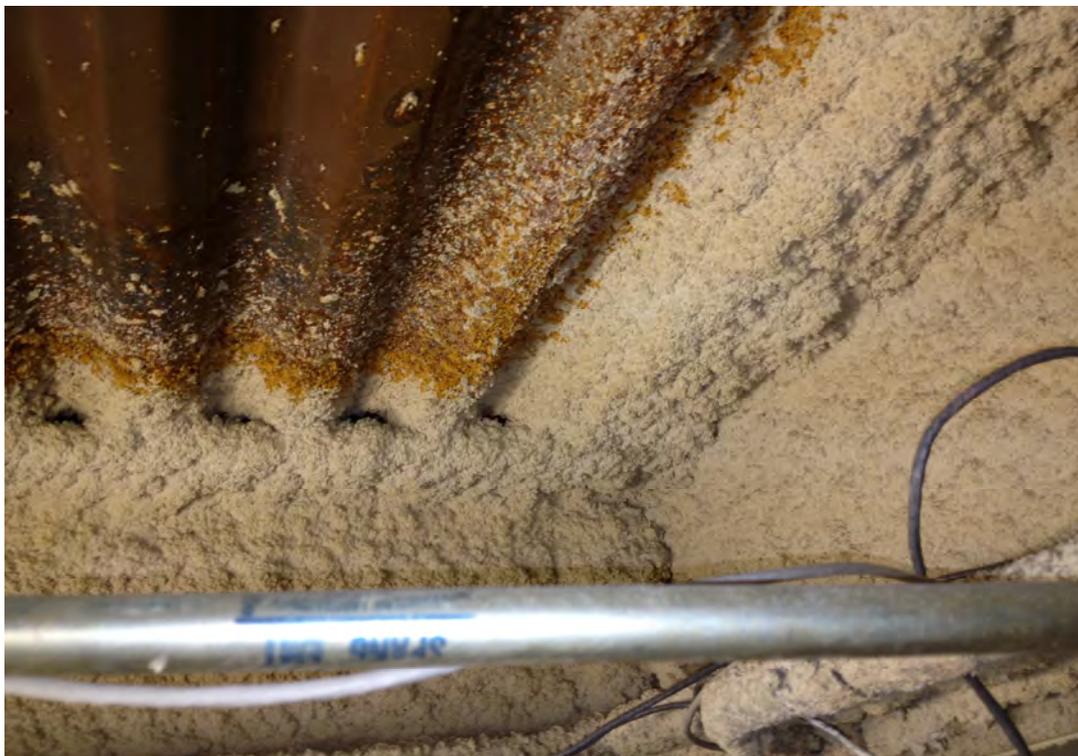
- **Spray-on fireproofing** on steel beams, observed above suspended ceiling tiles with limited overspray on the metal deck for both the 1st floor and 2nd floor ceilings. The asbestos-containing spray-on fireproofing was friable and observed to be in good to fair condition. Not all steel beams were coated with spray-on fireproofing. Approximately 3 beams with spray-on fireproofing were observed above first floor suspended ceiling tiles. The spray-on fireproofing was observed on the main east-west trending steel beam at the southern portion of the 2nd floor. Fiberglass batting insulation above the suspended ceiling in the 2nd floor muster/training room, the largest room on the 2nd floor, obscured portions of the overhead beams and steel deck. Approximately 2,400 square feet of steel beams and adjacent deck is assumed to be coated with spray-on fireproofing.

Photo #8 - View of ACM sprayed-on insulation on steel beams above the suspended ceiling tiles in the 1963 wing, 1st and 2nd floor ceilings.
 Photo Date: 04/25/2014 Sprayed on ACM insulation was observed on beams in the 1963 wing only.

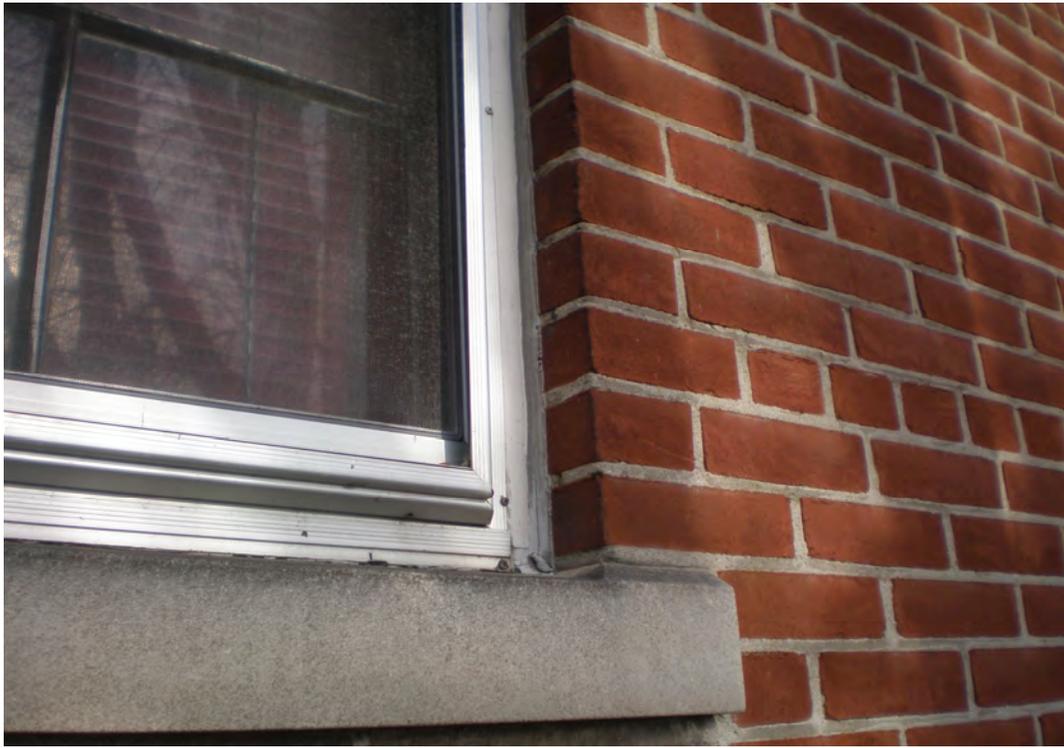
- The caulk at the bottom of the storm windows on the 1963 northwest building. PCB Aroclor 1248 was detected at a total concentration of 184 ppm (183,995 ppb) in a sample of the storm window bottom caulk. 14 storm windows were observed on the 1963 addition, each with a width of 40 inches at the bottom of the storm window at the window sill.

- Perimeter window caulk surrounding the storm windows on the 1963 northeast addition. PCBs were detected at a total concentration of 198.7 ppm (Aroclor 1254 at 71.125 ppm and Aroclor 1262 at a concentration of 127.588 ppm) in a sample of the window caulk. 14 windows were observed on the 1963 addition, each with a perimeter of approximately 17 linear feet (204 inches).

Photo # 9 - View of a storm window on the 1963 wing. This type of storm window was observed on all of the 1963 wing windows.
 Photo Date: 04/11/2014 The caulk around the windows on the 1963 wing was determined to contain PCBs greater than 50 ppm.

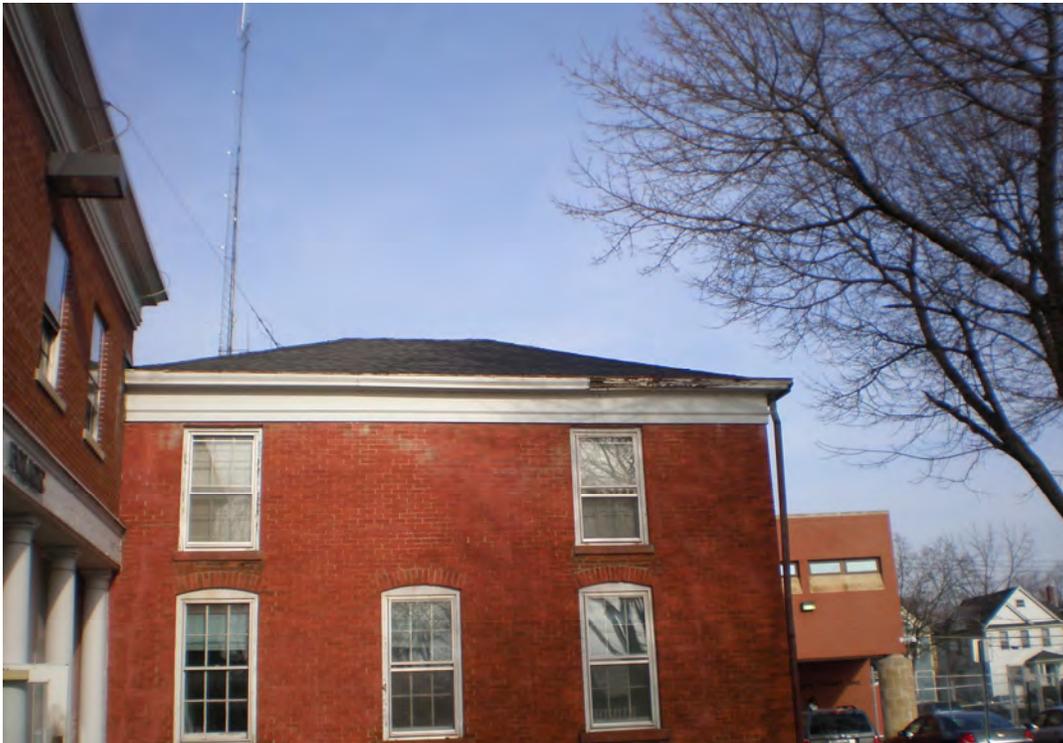
- **Exterior window glazing compound**. There are 17 windows with various number of panes (including a double window on the west side of the first floor), each with exterior window glazing compound. The exterior window glazing compound between the glass panes and window frames was determined to be ACM, in a seam approximately 1/4" to 1/2" wide. The window glazing compound is non-friable and was observed to vary from fair to poor condition.

Photo # 10 - View of windows on the 1918 wing. The window glazing compound was determined to be ACM.
 Photo Date: 04/11/2014 The ACM window glazing compound is present on windows on the 1855, 1976 and 1918 wings.

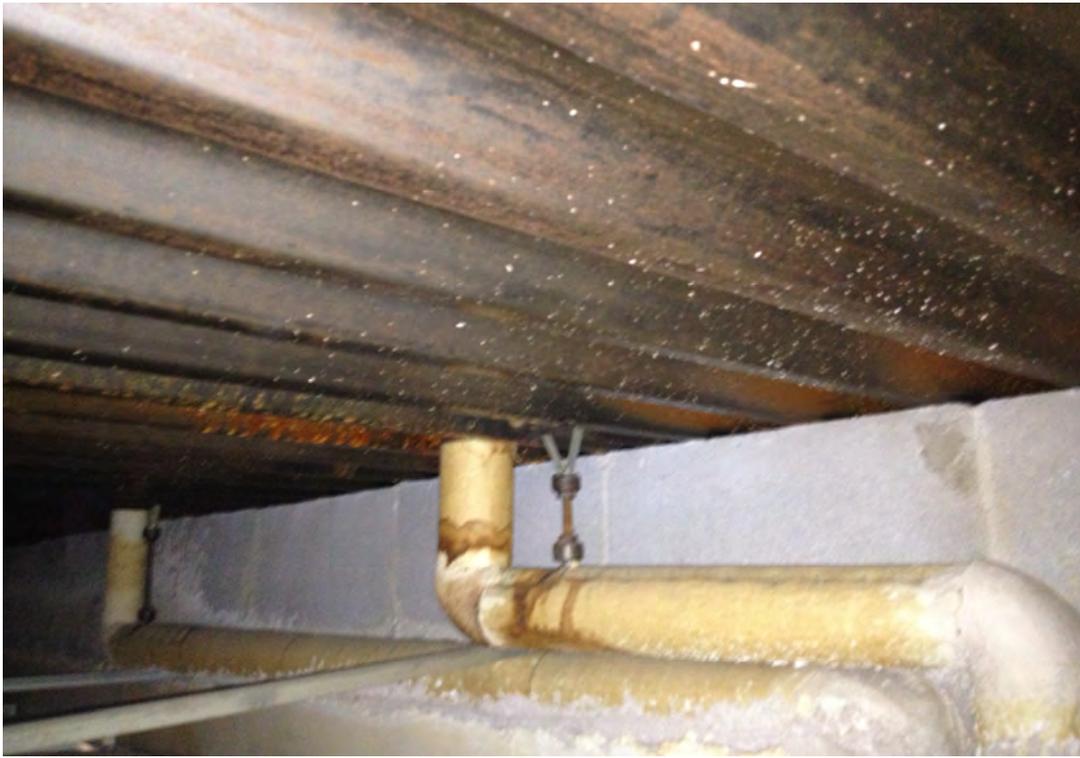
Photo #11 - View of mudded pipe fitting and fiberglass insulation in the 1963 wing.

The mudded fittings on insulated pipes in the 1963 wing were determined to be non-ACM.

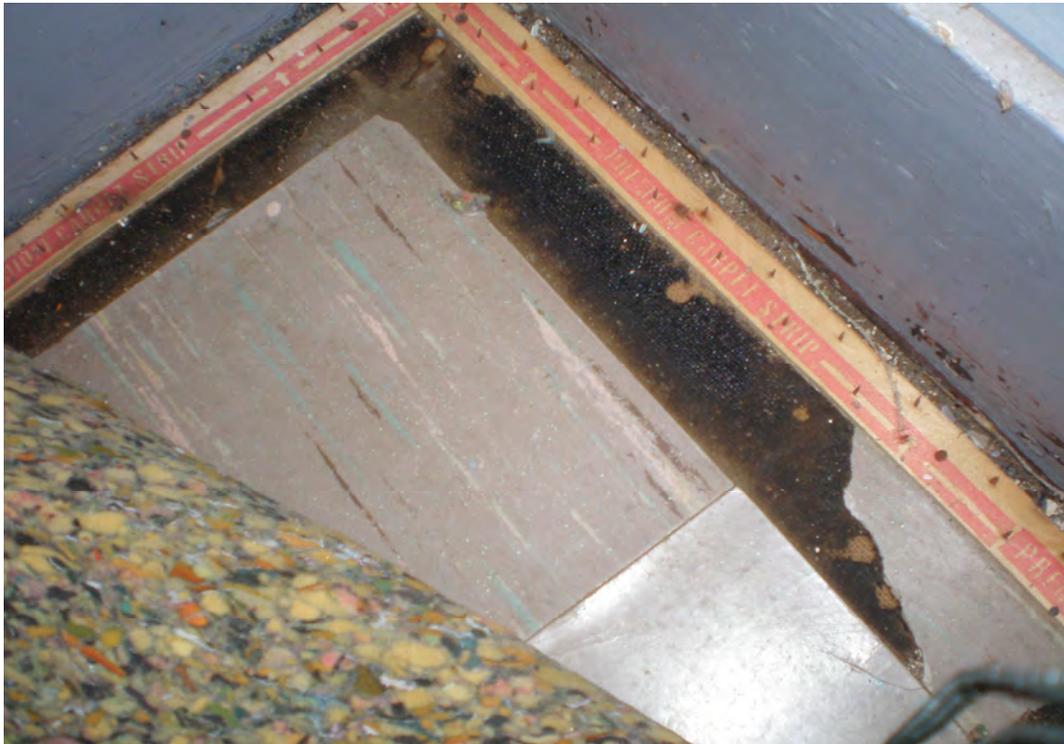
Photo #12 - View of ACM 9" x 9" floor tiles beneath carpeting, in the 1st floor hallway of the 1918 addition.

ACM 9" x 9" floor tiles were observed beneath carpeting at various locations in all facility additions.
