Genesee Co. Jail - Masonry Study
Batavia, NY

November 11, 2016

FLYNN | BATTAGLIA
ARCHITECTURE | PRESERVATION | PLANNING | BUILDING SCIENCE

TABLE OF CONTENTS

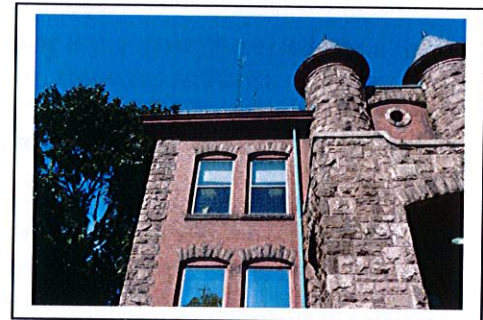
The stone entrance canopy is in fair condition and exhibits some distress cracking and displacement reflecting movement associated with the porch. Interior surfaces of the supports are in need of repointing. The east side of the stone archway at the top of the stair shows evidence of displacement requiring re-setting and re-mortaring. A tongue and groove, painted wood ceiling is separating from its perimeter and showing signs of warping which is a probable result of water damage.

Entry Canopy with Turrets beyond.

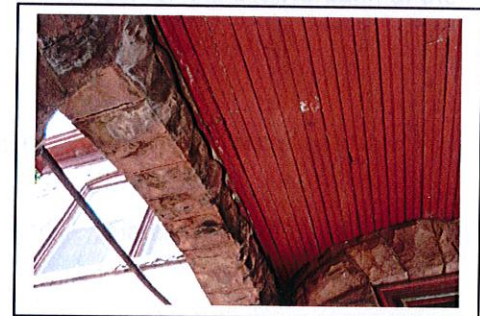
Underside of Entry Canopy Roof.

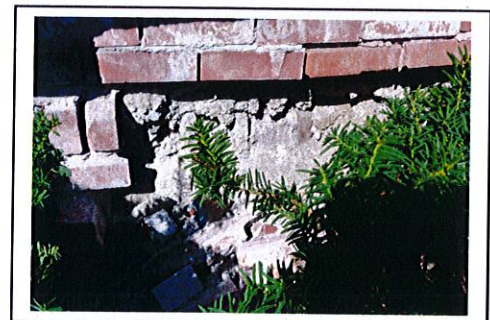
The stone porch is in poor condition. Evidence of displacement, heaving, and cracking indicate movement probably due to water infiltration and freeze/thaw cycling. Cap stones on the low walls display evidence of wall heaving and/or settlement. At the west side of the porch the stone window arch has pulled away from the brick back-up and collapsed. The interior brick facing of the porch walls show signs of step cracking and some areas require repointing. The concrete floor slab of the porch is cracked. Further investigation

Collapsed window opening, west side.

1. Conditions at the porch are evidence that this face of the building is the most distressed. As a result, we suggest reconstruction of the above grade walls, stone facing, stone cap and brick masonry, including corrective measures for the floor porch drainage. All horizontal joints in the stone cap should receive a lead cap-flashing at all low porch walls to prevent water infiltration into the porch walls.
2. The stone entrance canopy structure should be re-pointed where indicated and the stone archway should have displaced stones re-set. Drainage should be thoroughly investigated and corrective measures taken to properly direct water away from the stone walls.

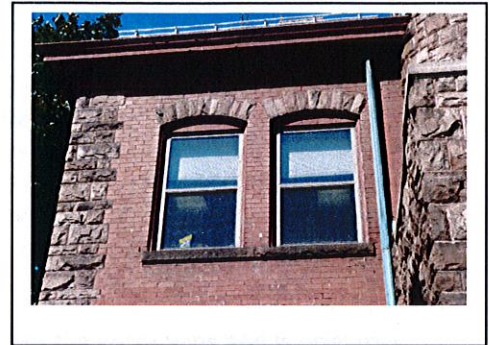
The existing replacement windows are in good condition. The sash and glazing appears to be sound. The original frames in place have multi-layers of paint and need minor patching.

South facing windows.

3. The face brick should be re-pointed where indicated.
4. All brickwork and stone should be cleaned with a mild detergent and a very low-pressure water spray.
5. Original window frames should be scraped, patched, prepped and re-painted.
6. Soffit boards with decay damage should be replaced.
7. Scrape, prep and re-paint frieze boards, soffits and cornice pieces.

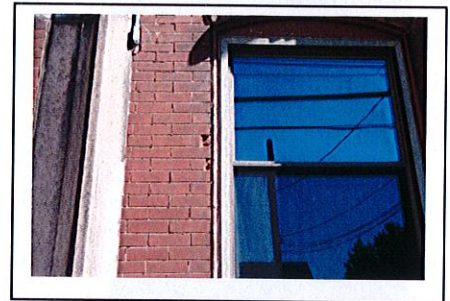
The brick is generally in good condition with some minor areas in need of re-pointing. Most notable of these areas is the central dormer parapet above the Sheriff's Office entry. Some chipped brick occur near the meeting rail of the window to the south of the Sheriff's Office entry doors.

Damaged brick at meeting rail.

1. Re-point the stone base, cap, and turrets as indicated.
2. Face brick should be re-pointed where indicated. Chipped brick should be replaced with salvaged brick if an existing quantity is available or with a compatible match.

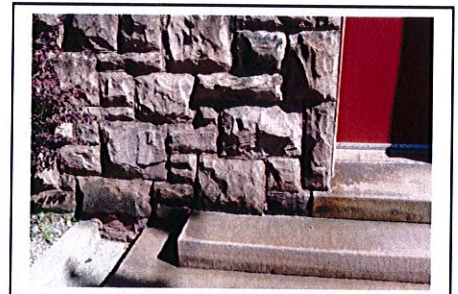
The stone base is in relatively good condition. The areas in need of re-pointing are adjacent to each side of the Sheriff's Office entry steps where the rusticated stone meets the stone slab steps. Several joints in the stone cap/sill band need re-pointing and several sandstone units require surface repair.

Open joints at either side of steps.

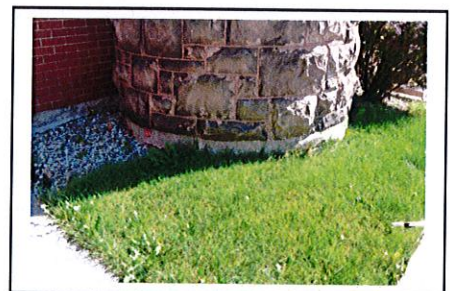
The stone turrets are in good condition with minor re-pointing required. Areas of inside corners abutting the brick at the Sheriff's Office entry wall need re-pointing. There are open joints in the stone above the second floor window of the south turret adjacent to the Sheriff's Office entry. The base of both turrets has a parged coating, presumably cementitious, that covers the exposed brick foundation wall. Grade has receded here and exposed the brick foundation.

Parged base of turret.

3. Parged material should be removed and replaced with a similar material in a color to match the stone.
4. All brickwork and stone should be cleaned with a mild detergent and a very low pressure water spray.

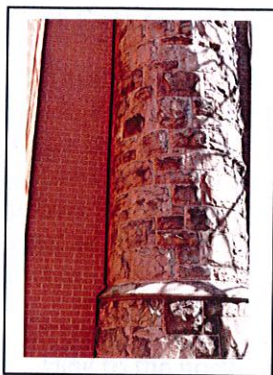
Open expansion joint.

The expansion joint between the historic building and the 1980's addition lacks sealant from the resilient expansion material to the face of the brick.

5. Rake joint at stone pilasters and brick; install silicone sealant.
6. The expansion joint should be filled with a preformed silicone faced joint filler that matches the color of the brick.

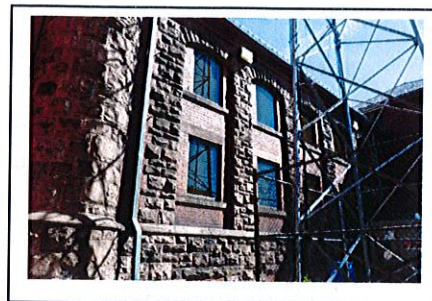
The stone pilasters and segmental arches are in good condition. The return joints between the pilasters and the brick wall require sealant.

Stone pilasters at brick.

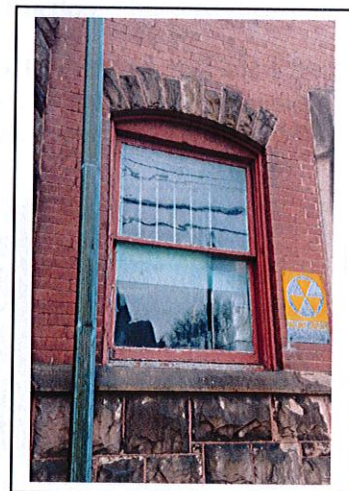
The existing replacement windows are in good condition. The sash and glazing appears to be sound. Some original wood sash windows remain in place and appear serviceable. All original frames in place have multi-layers of paint on them and some need minor patching.

Wood window & frame.

7. Original windows frames should be scraped, patched, prepped and re-painted. At replacement windows, original window frames should be scraped, patched, prepped and re-painted.

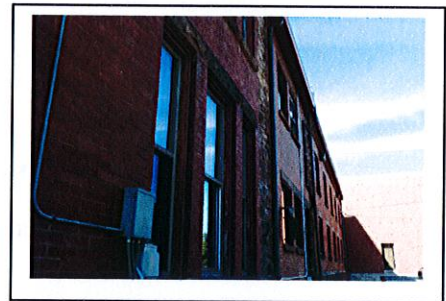
- **Brick**
The brick is in good condition. There is an abandoned opening in the brick at the southern-most, first floor window lintel.
- **Stone Base**
The rusticated stone base is in good condition. There are a few joints in the stone cap/sill band that require repointing.
- **Stone Window Sills**
There are lug sill joints at the ends of the first floor window sills at the infill elevation that require re-pointing.
- **Stone Arch**
The stone arch above the louver at the south building dormer parapet has open joints that require re-pointing.
- **North Expansion Joint**
The expansion joint between the historic building and the mid-1980's addition lacks sealant out to the face of the brick.

Brick conditions at East.

1. The brick opening should be infilled with matching brick.
2. The stone arch above the louver requires re-pointing.
3. The stone cap/sill band and lug sill joints require re-pointing where indicated.
4. All brickwork and stone should be cleaned with a mild detergent and a very low pressure water spray.
5. The expansion joint requires a preformed silicone faced joint filler.
6. At replacement windows, original window frames require scraping, patching, prep and re-painting.
7. Scrape, prep and re-paint frieze boards, soffits and cornice pieces.
8. Review and possible repair of integral gutters at south and north buildings.

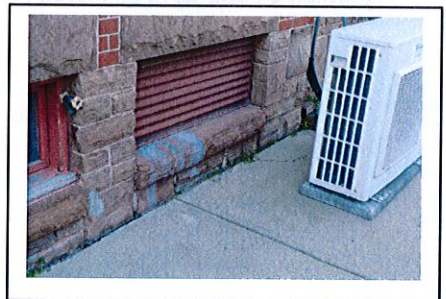
Stone base, open joints.

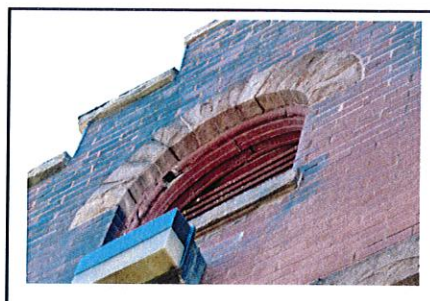
Open joints at arched window.

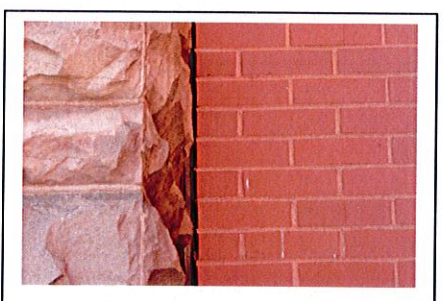
Open expansion joint.

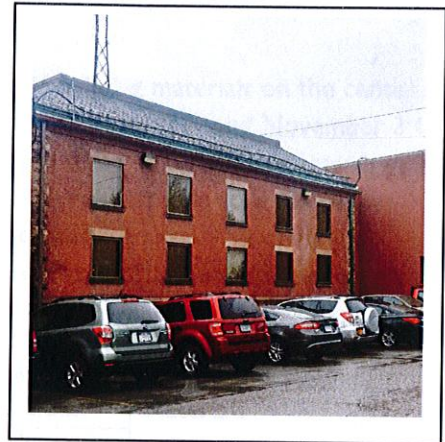
The existing replacement windows are in good condition. The sash and glazing appears to be sound. Some original wood sash windows remain in place and appear serviceable. All original frames in place have multi-layers of paint on them and some need minor patching.

Windows in North building.
