Genesee Co. Jail - Masonry Study
Batavia, NY

November 11, 2016

FLYNN | BATTAGLIA
ARCHITECTURE | PRESERVATION | PLANNING | BUILDING SCIENCE

TABLE OF CONTENTS

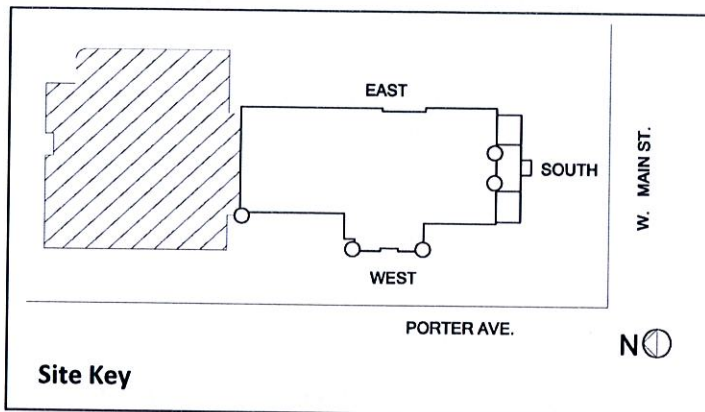
South Façade

The Main Entrance façade fronts W. Main St. It is comprised of a smooth red face brick wall, rusticated sandstone porch and center canopy with symmetrical arrangement of paired, wood entrance doors flanked by semi-circular stone turrets, paired window openings in the brick wall with stone segmental arches, framed by stone quoins at the corners.

The smooth red face brick is in good condition overall. There are various locations in need of joint repointing mainly from the first floor windows up to the soffit level.

The stone entrance canopy is in fair condition and exhibits some distress cracking and displacement reflecting movement associated with the porch. Interior surfaces of the supports are in need of repointing. The east side of the stone archway at the top of the stair shows evidence of displacement requiring re-setting and re-mortaring. A tongue and groove, painted wood ceiling is separating from its perimeter and showing signs of warping which is a probable result of water damage.

The stone turrets are in good condition with very little visible need of attention. The turret stone/flashing interface at the canopy roof could not be verified as the roof was not accessed.
